PROBLEM SOLVER

BORON CUTTER MAKE SHORT WORK OF SPOT WELDS

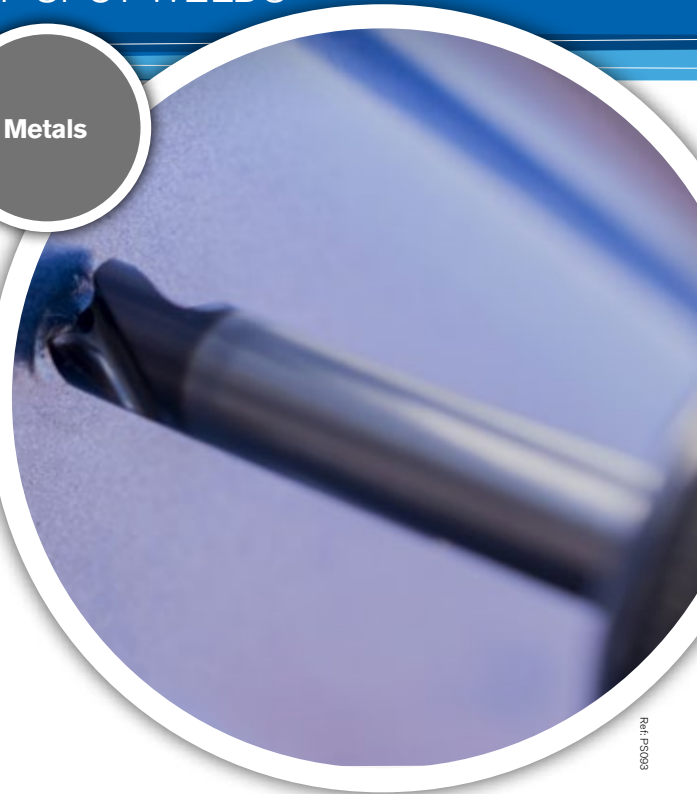
Ref: P5033

Solution: A new three cutting edged **Boron Cutter** was developed with multilayer alloy coating technology. This gives the drill bit the ability to cleanly cut through these new materials. Extreme high heat insulation and dispersion characteristics, offer excellent wear, prolonging tool life.

This technically advanced drill is more effective and cost efficient when drilling through these new high strength materials. Correct cutting fluid will also extend the life of the drill bit.

Problem: A large fabrication workshop were experiencing problems, when drilling Boron spot welding on cages. It's resistance to conventional cutting tools, such as spot weld drills, and standard cutters etc. were ineffective..
